Steer Clear

Perfecting the nerve center of your GM musclecar's most important system

Text and photography by Tom Shaw

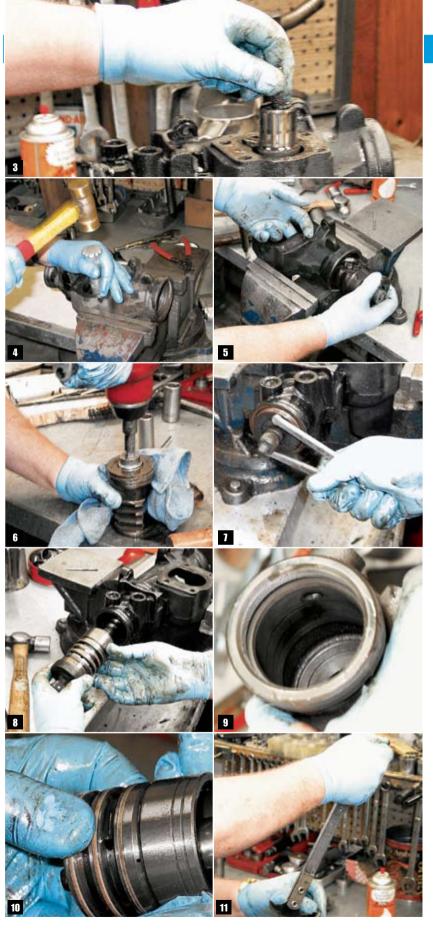
- 1 The job begins by removing the pitman arm nut, then the pitman arm is removed with a puller. "Never hit it with a hammer to remove it or use a "picklefork," cautions Chip. "That makes the case out of round for the seal, and it can crack the case." Moving around to the front, a 12-point 7/16 socket loosens the coupler (aka. rag joint), which is then tapped off with a hammer.
- 2 Even though it's on top, it's called the Side Cover, and it comes off next. Four bolts are removed, then the threaded adjuster stud, at the top of the pitman shaft, is turned clockwise with an Allen wrench to remove the cover from the shaft.

- 3 With the "side cover" off, the shaft is gently tapped out with a soft copper mallet and set aside. This one looks pretty good compared to boxes taken from cars that sit. Moisture collects in the boxes and corrodes the shafts, which will then need extensive machining or replacement.

- 4 Now, the lower Pitman shaft bearing, seals, and washers are driven out with a hammer and aluminum driver.
- 5 A pin punch is driven down through the hole in the top of the case to unseat the snap ring. Once the snap ring is removed, the input shaft is rotated to pop the end cap out. Keep spinning the shaft and the rack-piston assembly will be the next item out.

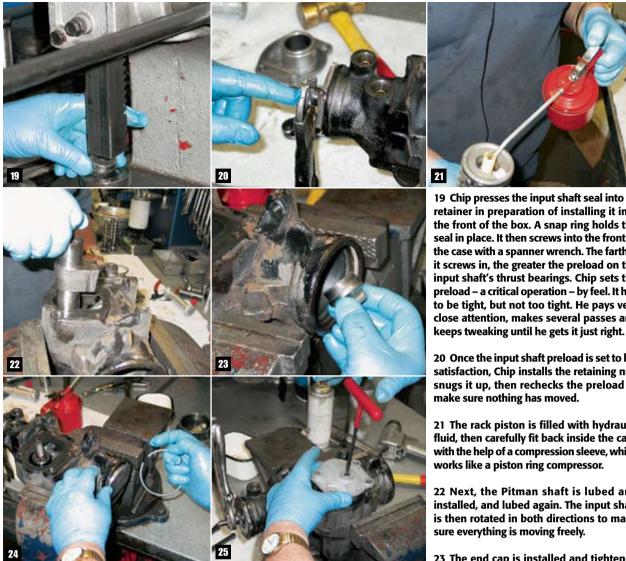
20 Once the input shaft preload is set to his satisfaction, Chip installs the retaining nut, snugs it up, then rechecks the preload to make sure nothing has moved.

21 The rack piston is filled with hydraulic fluid, then carefully fit back inside the case with the help of a compression sleeve, which works like a piston ring compressor.

22 Next, the Pitman shaft is lubed and installed, and lubed again. The input shaft is then rotated in both directions to make sure everything is moving freely.

23 The end cap is installed and tightened very securely.

24 The O-ring is covered in lube and set in its channel, then the end cover is replaced and secured by the snap ring. Once everything is in place, a few light taps with a brass mallet gets things seated. Hey, this thing's starting to look like a steering box.

25 An O-ring is set with stiff lube into the channel of the side cover, then the top of the Pitman shaft is rotated to bring the side cover down flush, and four new bolts are installed. A dab of silicone sealer is then applied to the shaft where it extends through the side cover. "The only place you ever use silicone in a power steering system is right here on this little bolt," Chip stresses, adding that silicone and power steering systems are a very bad combination.

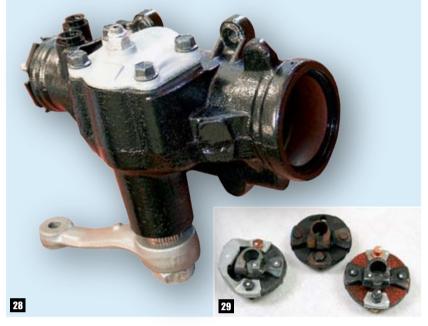
27 Once the box is buttoned up and all the adjustments are made, Chip screws in two Schrader valves to the hose connections and pressurizes the box with 110 psi of compressed air. Then he sprays soapy water on areas where leaks could occur and checks for bubbling. Chip says that air will leak before hydraulic fluid, so if a box is air-tight, it won't leak fluid. This one passes the air pressure test easily.

28 The case is cleaned with degreaser, shaft ends are protected from overspray and the Side Cover is masked off with tape, then the box is painted gloss black (OEM color for a 1964-1967 GTO) and the Pitman arm cast gray. A final coat of clear keeps the bare aluminum Side Cover from oxidizing. The finished box is now rebuilt, correctly set up with the quicker 12:1 ratio, tested, and ready to ship. Extreme detailing is also available.

29 Two details yet remain-the flex joint and the old power steering pump. Flex joints, aka couplers, rag joints, donuts,

etc., are available in OEM style (right), and an updated design that prevents steering loss in the event of a flex joint failure. Chip discounts flex joints from \$69 to \$59 when you get a steering box rebuilt. The last item needing changed is the power steering pump. It's full of 40 years worth of dirt, sediment, varnish, moisture and plenty of other contamination, and as soon as you connect it to your rebuilt steering box, it's going to share the mess. Also, older pumps generally have some loss of pressure, so don't cut corners now. Replace the pump too. Chip also discounts pump services if the customer is getting a steering box rebuilt.
